IDALIA ROAD PHASE I-A/B STUDY

CN A300201

PUBLIC MEETING NO. 1

EXISTING CONDITIONS

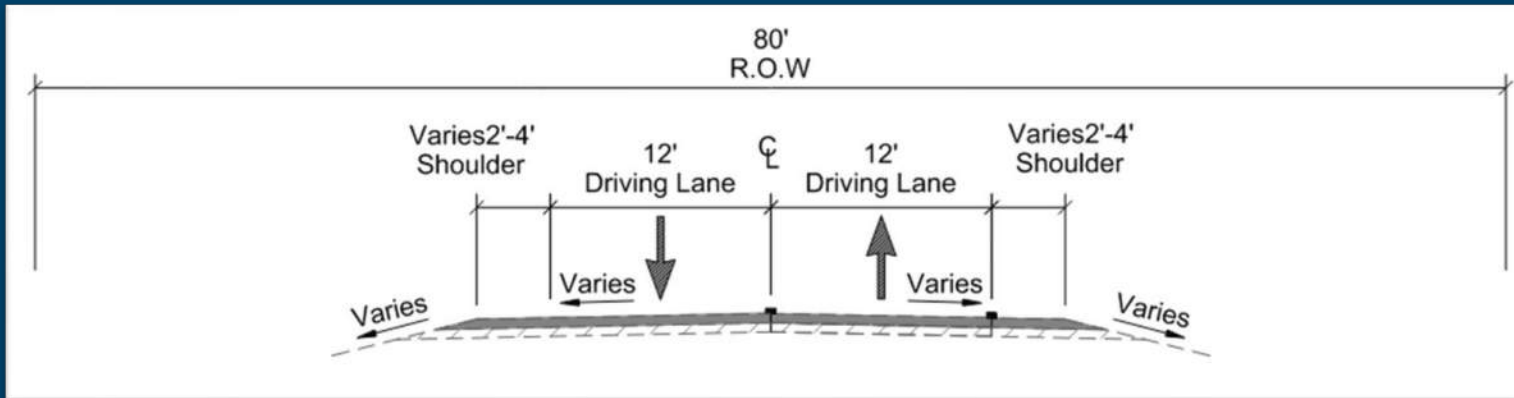
Typical Roadway Section (except intersections)

- Urban Minor Arterial Roadway Classification
- 2-12' Driving Lanes with narrow shoulders
- 80' Wide Right-of-way
- 35 & 40 mph Posted Speed Limit
- Turning Lanes at Signalized Intersections only
- Curb and Gutter near Iris Rd.
- Crossing Culverts at intersections
- No storm drain system
- Existing Utilities throughout corridor

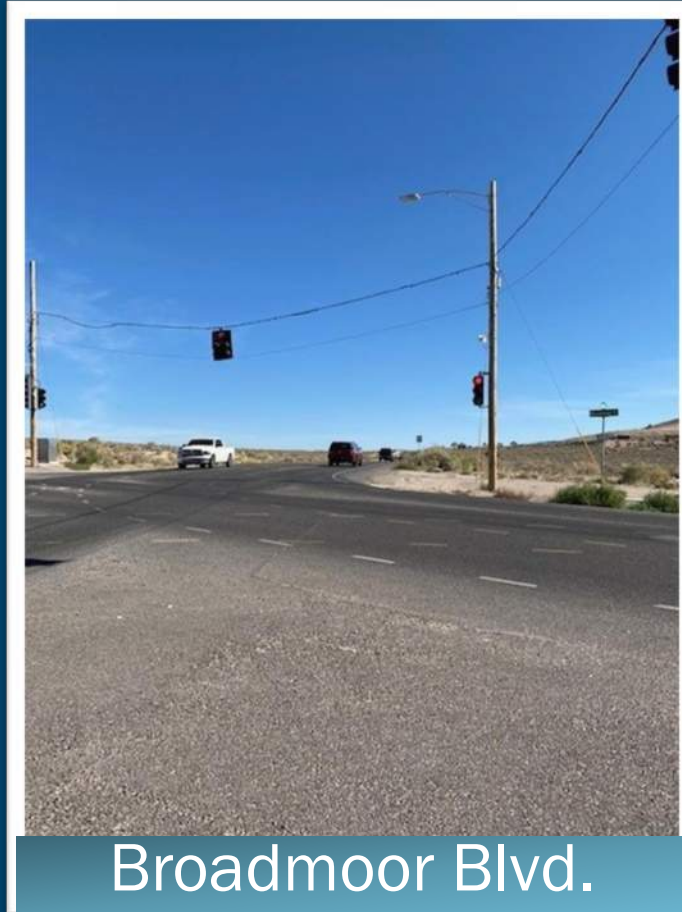
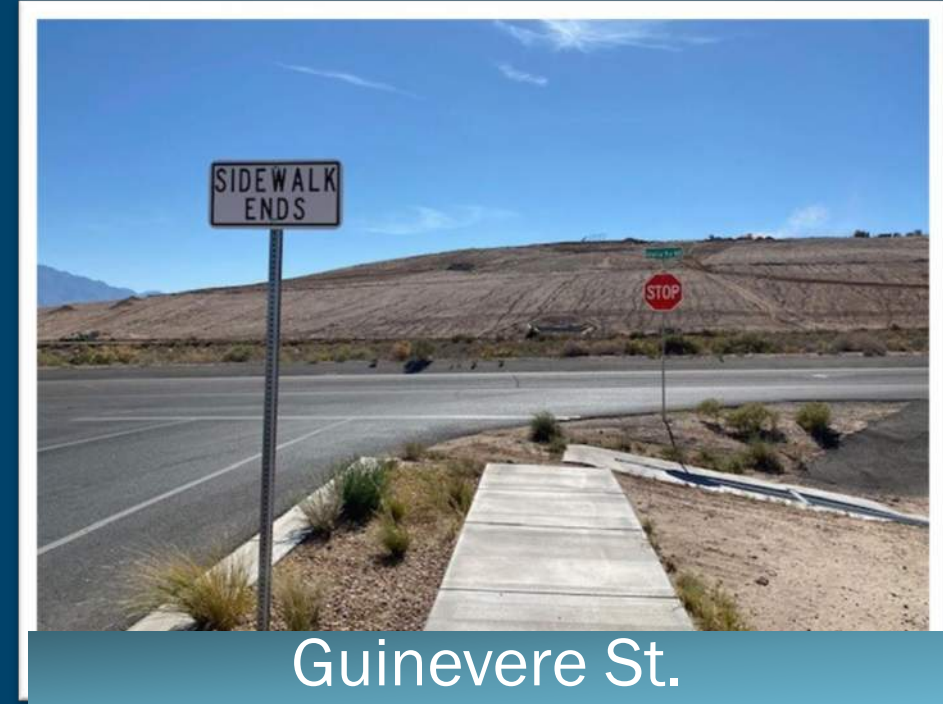
- ADA Curb Ramp Slope Issues
- Push Buttons Up to Date at Intersections
- Proximity of power poles for temporary signals

- Lack of Curb Ramps
- No Sidewalk Connectivity
- No Bicycle Lanes

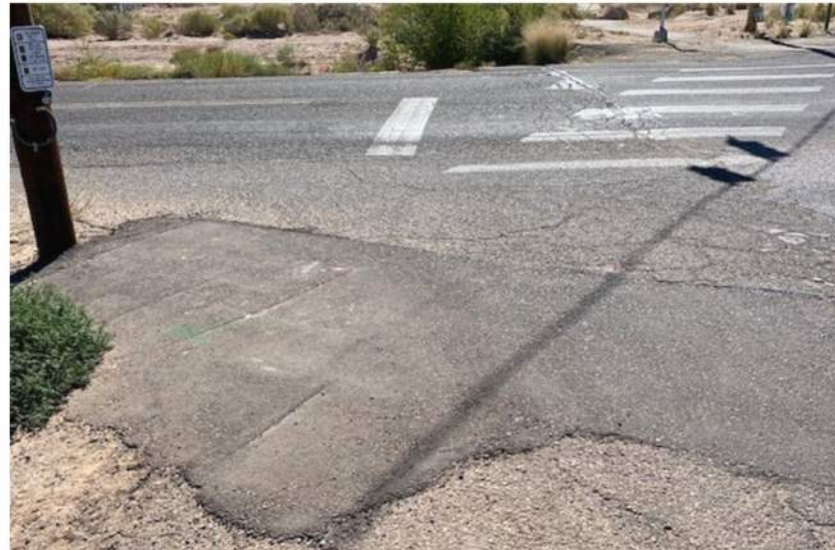
Loma Colorado Blvd. Ramps

- Curb Ramps do not meet current standards
- No Sidewalk Connectivity
- Missing Pedestrian Crossings

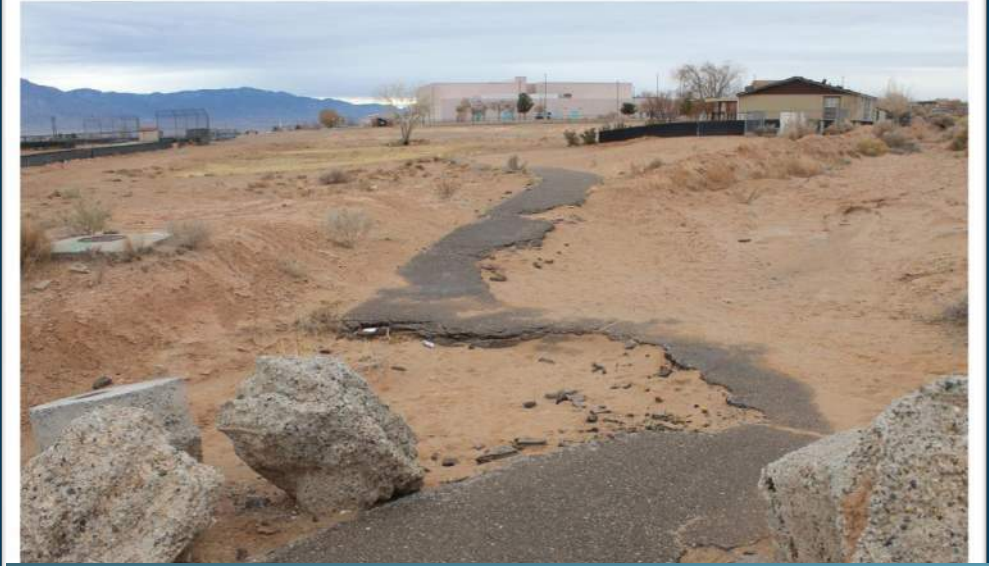
Trail to Rio Rancho M.S.

- Trail Connectivity to intersection from school
- Trails are old and not currently unusable for wheelchair access

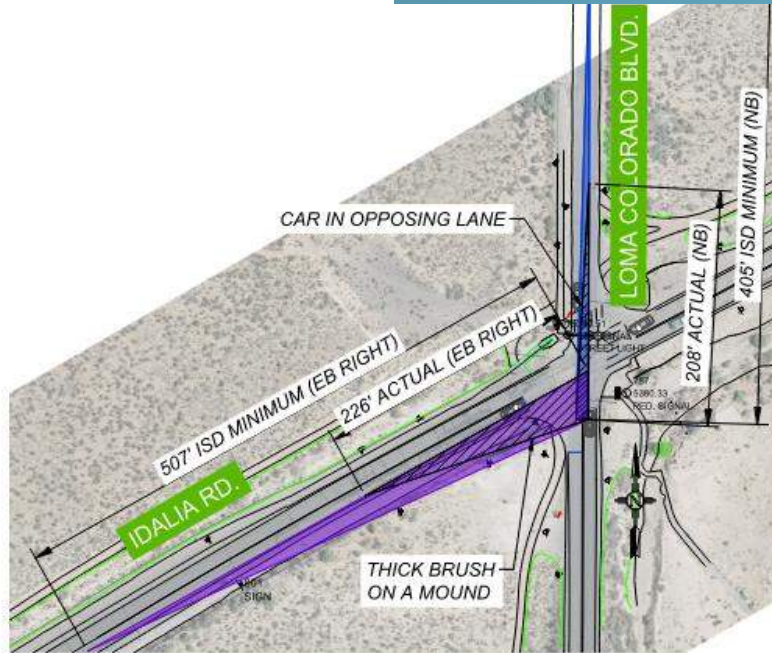
NORTHBOUND RIGHT & LEFT

- Stopping Sight Distance
 - “Sight distance is provided at intersections to allow the drivers of stopped vehicles a sufficient view of the intersecting roadway to decide when to enter the roadway or cross it”.
- Issues
 - Left-Turning Vehicles Block other turning vehicles.
 - Bushes and hills for Right-Turning Vehicles limits clear sight line.

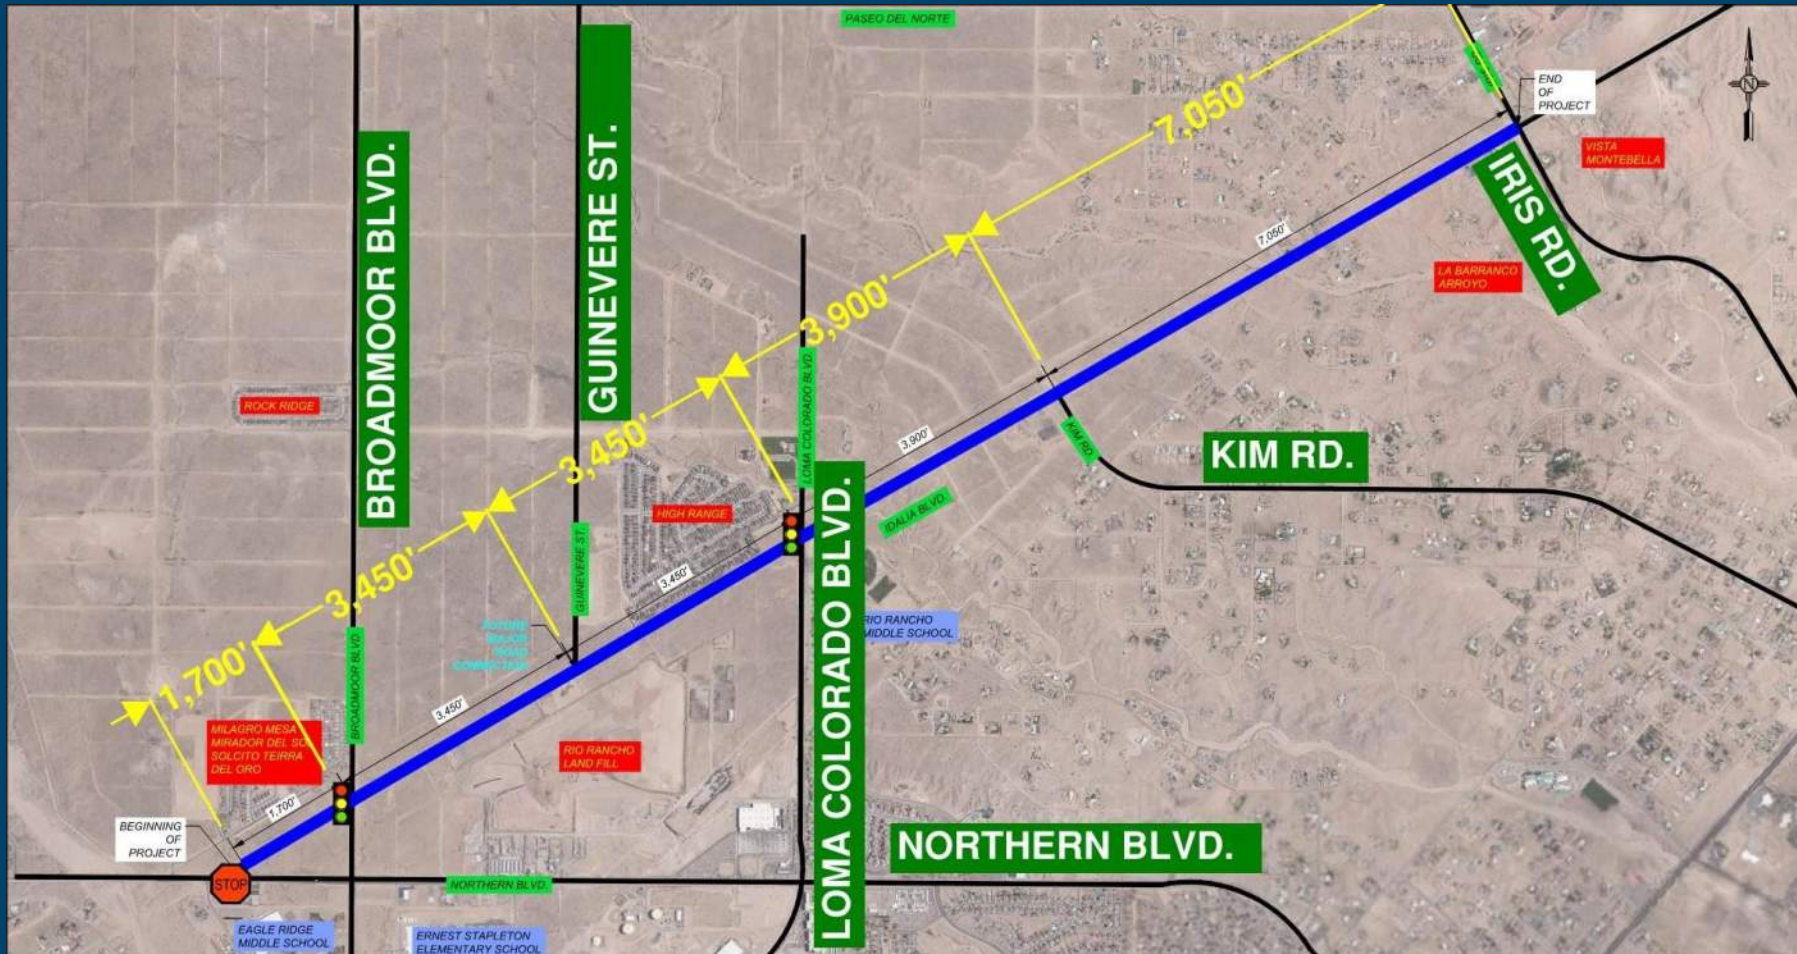
- Existing Spacing currently meets guidelines for major intersections.
- Direct access for property owners near Iris Rd.

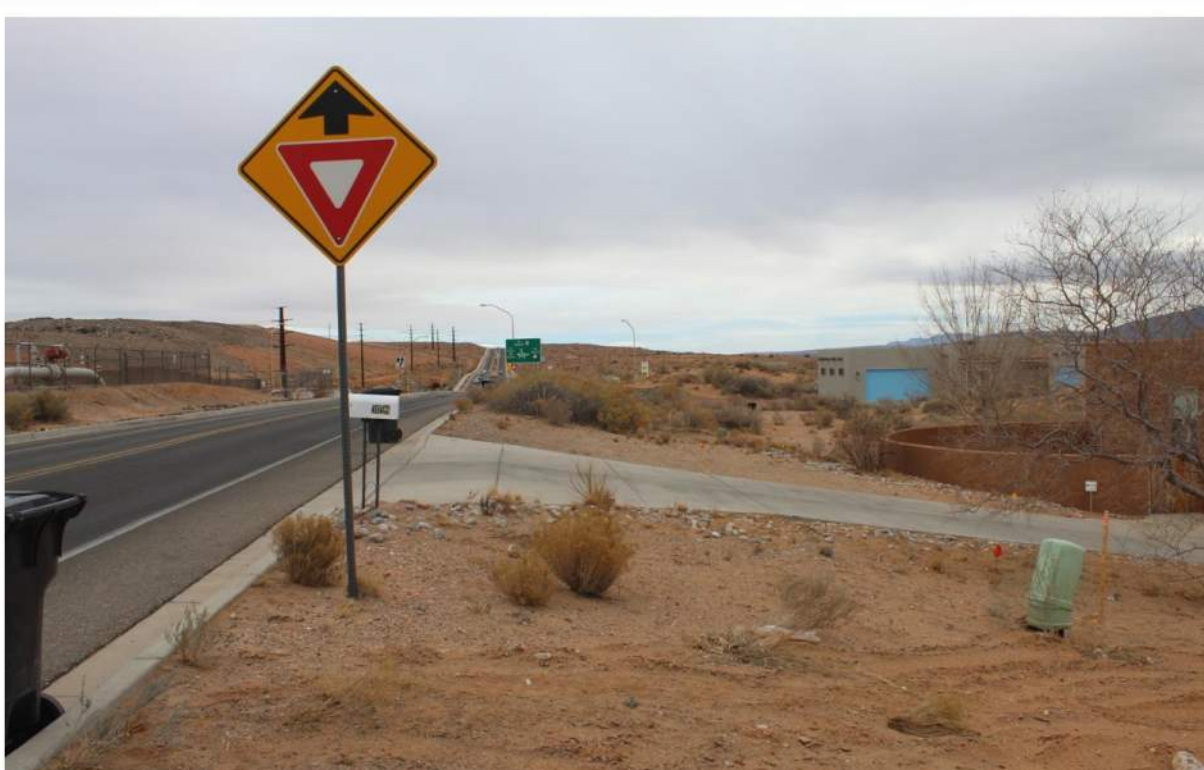
Private Driveway Access near Iris Rd.

- Access to private driveways
 - Existing Driveways have access near Iris Rd.
 - Steep driveways
 - Only access will need to be maintained from Idalia Rd.

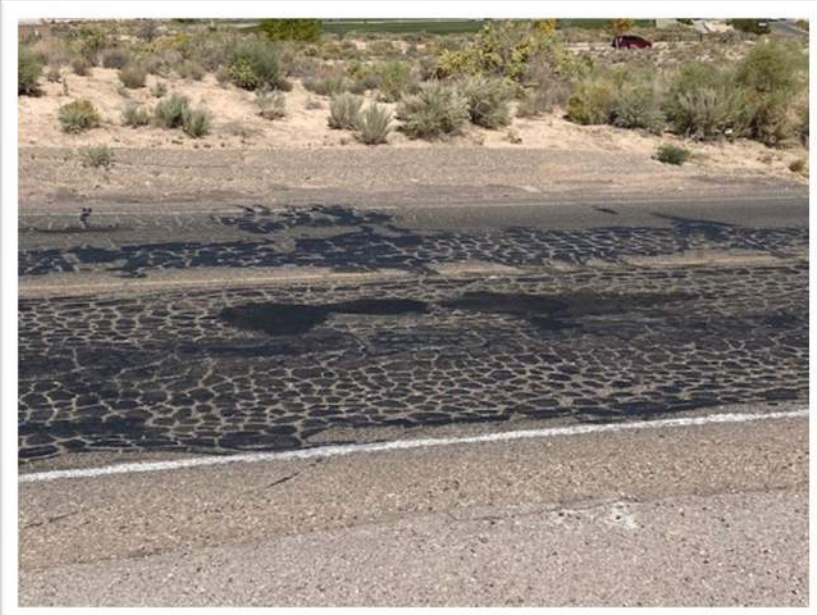
Alligator Cracking west of
Loma Colorado

- Alligator Cracking
- Aging Asphalt
- Chipping and Exposed Subgrade that may result in potholes
- Consistent Maintenance expected if not replaced

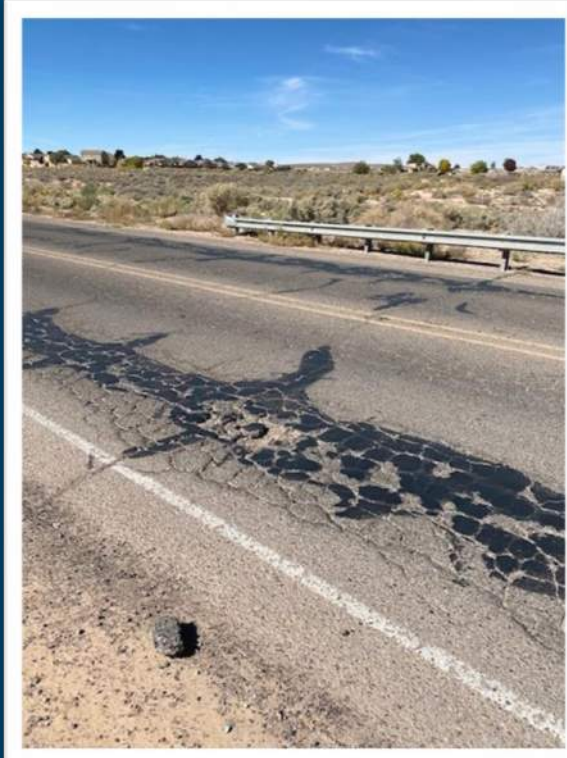
At Culvert Crossing
Drainage Structure

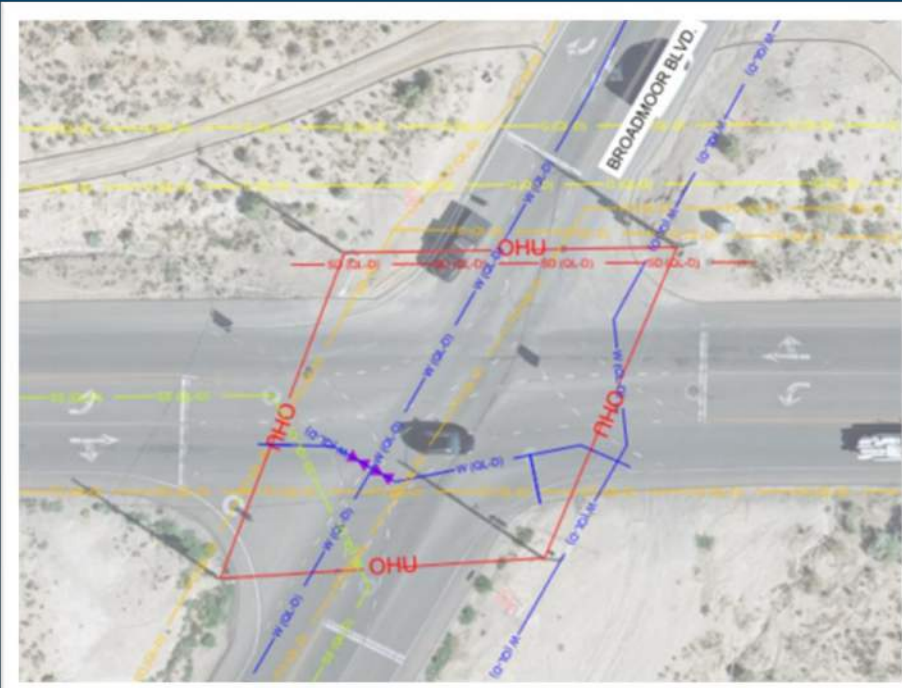
Broadmoor Intersection

- Above Ground:
 - Lighting at intersections
- Underground:
 - Waterlines
 - Sanitary Sewer Lines
 - Gas Lines
 - Fiber Optic Lines
 - Electrical

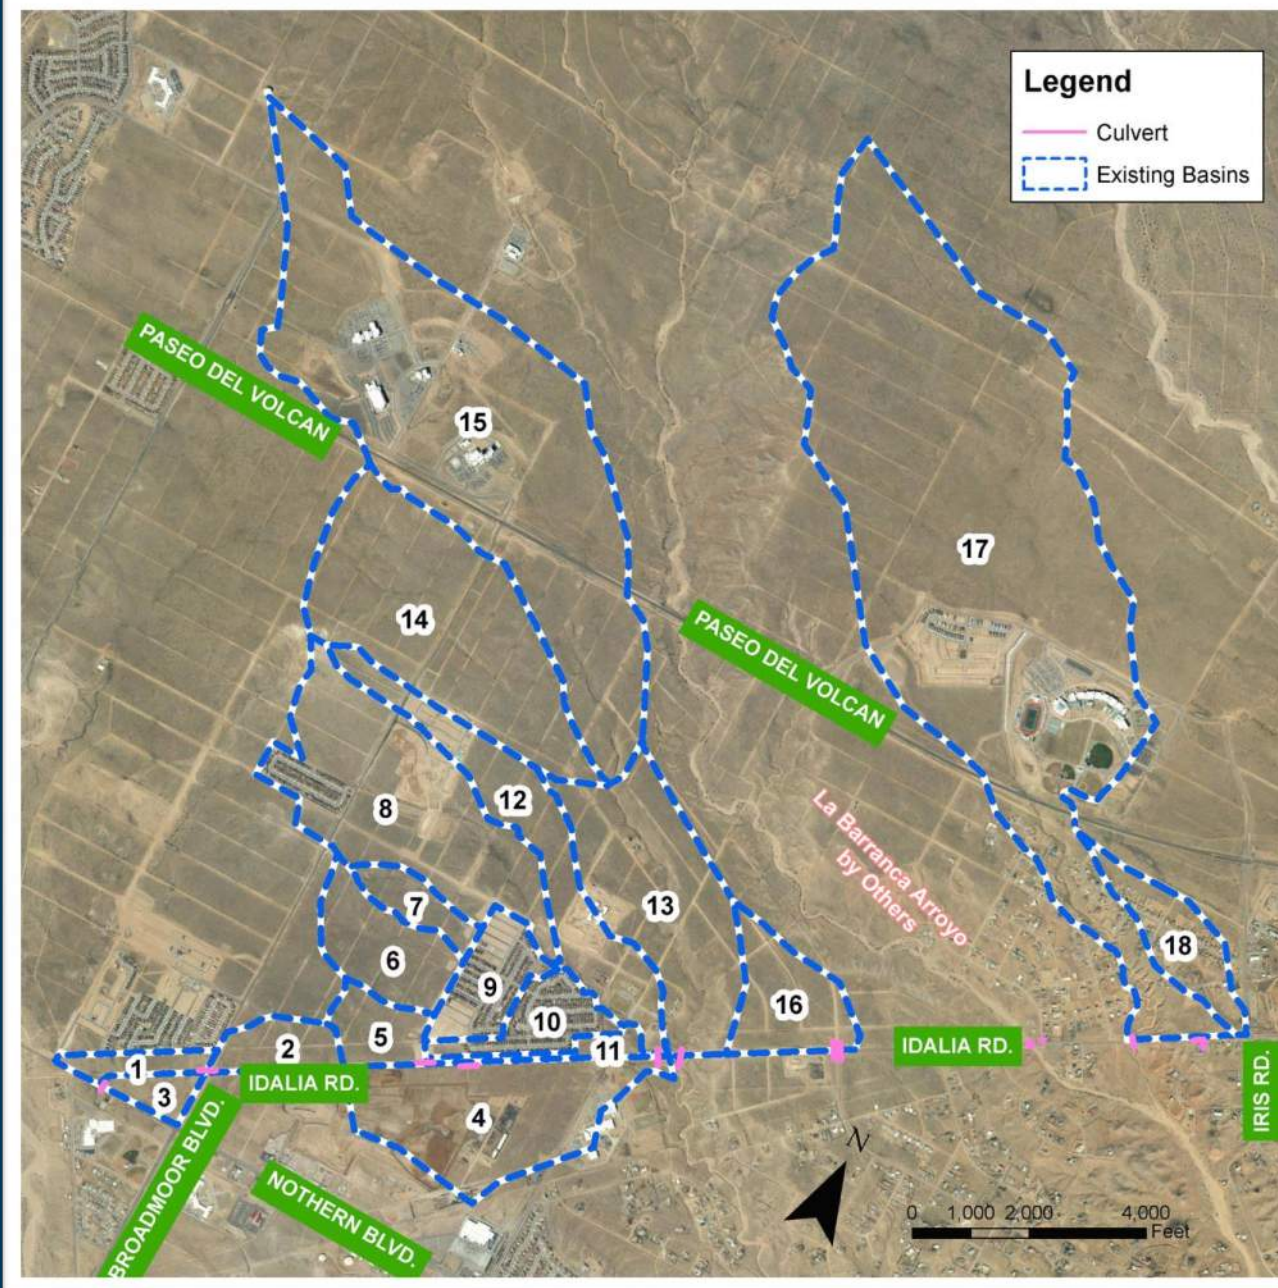
- Existing watershed basins draining to Idalia Road project site. Peak 100-yr and 10-yr runoff rates were developed for all structures and roadside ditches along Idalia Road within the project.
- La Barranca Arroyo is being analyzed in a separate project.

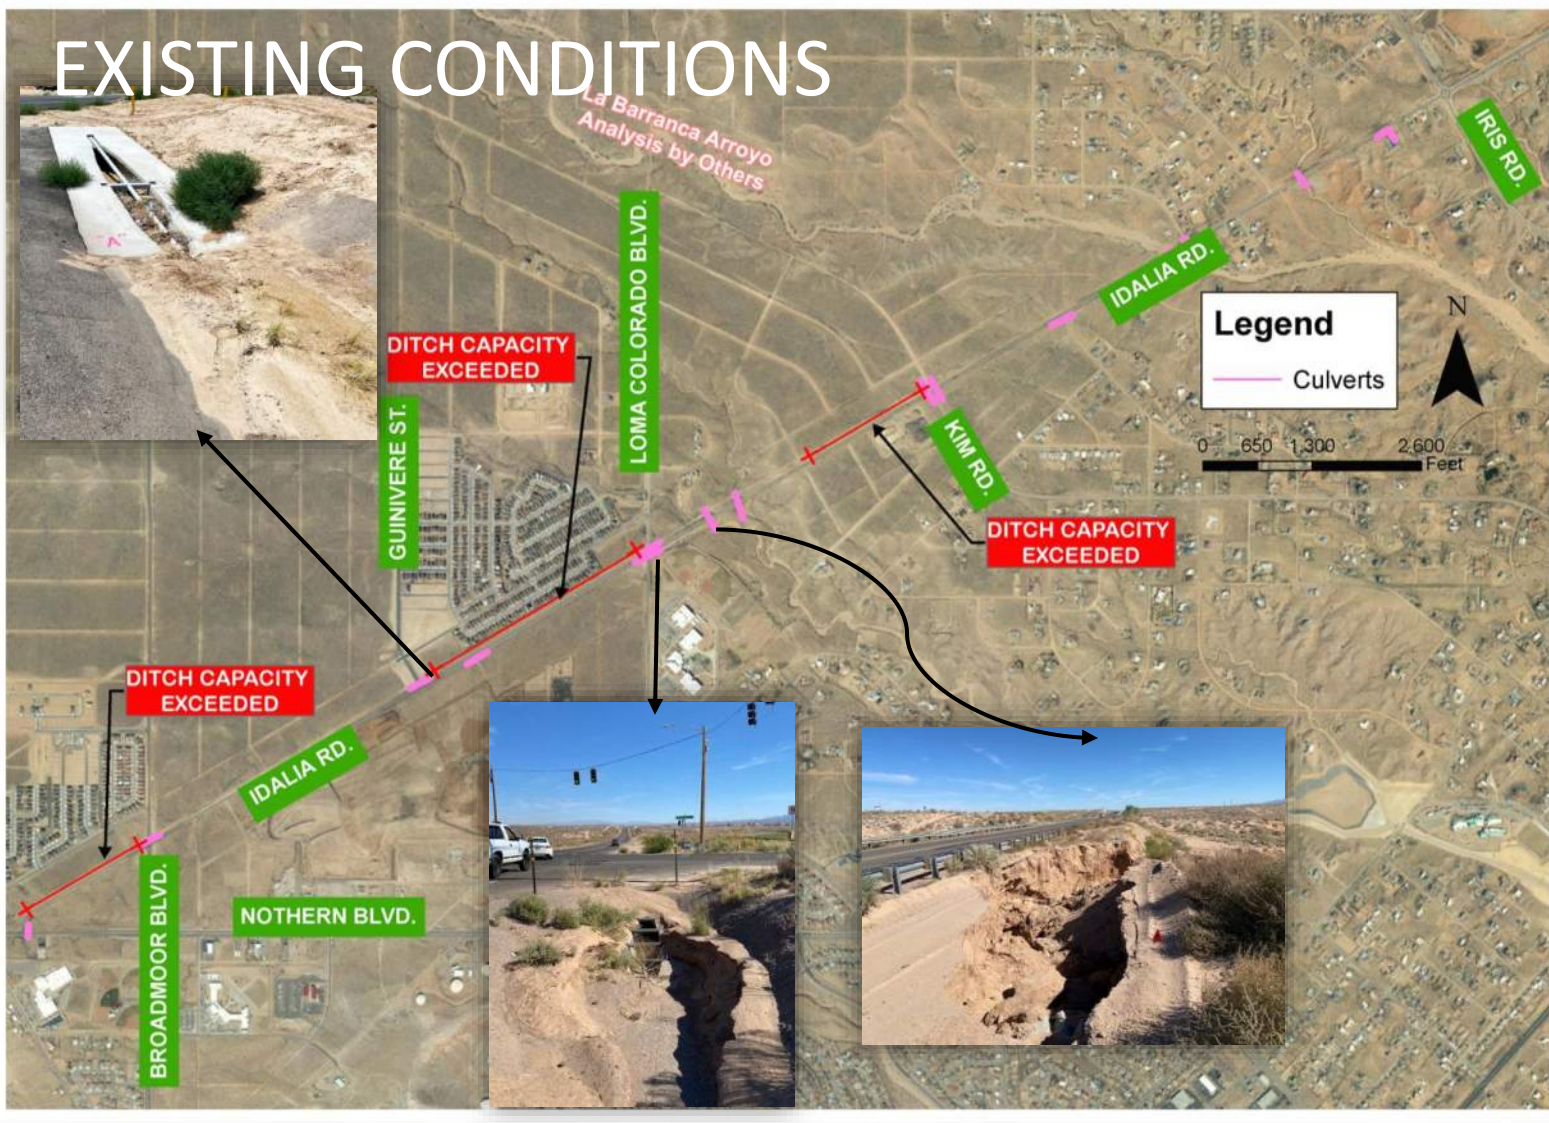
- Ditches parallel to the roadway were evaluated comparing the estimated runoff against the flow capacity of the ditch.
- The design storm exceeds the capacity of the ditches shown in red.

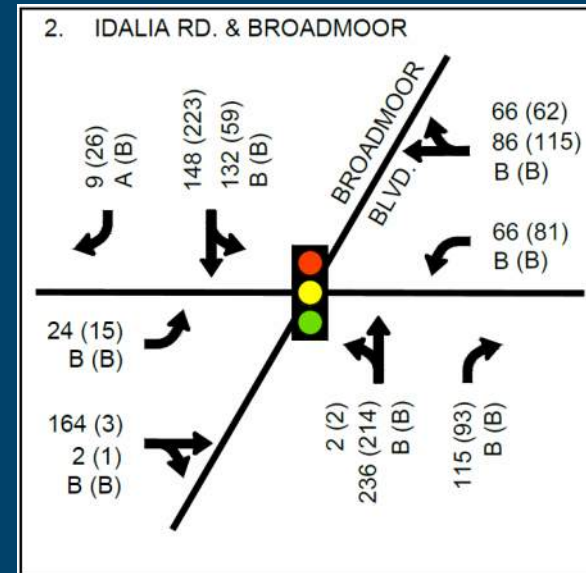
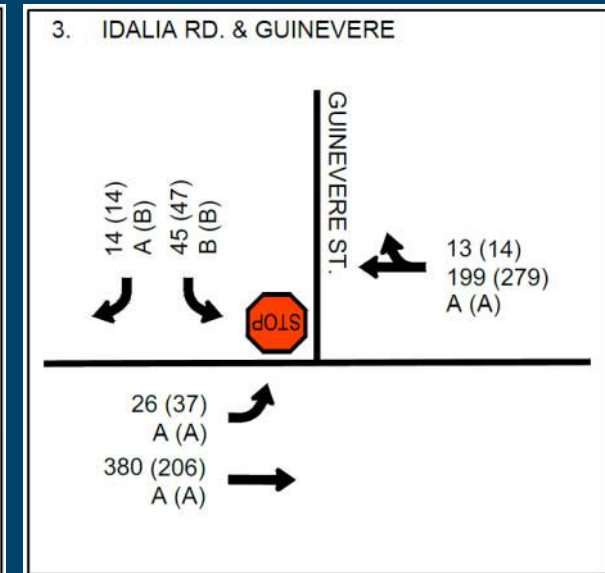
Intersection	Existing Conditions	
	2021 LOS	2040 LOS
Northern Blvd.	A-C	A-F
Broadmoor Blvd.	A-B	B
Guinevere St.	A-B	A-C
Loma Colorado	A-B	B-C
IrisRd.	A	A-B

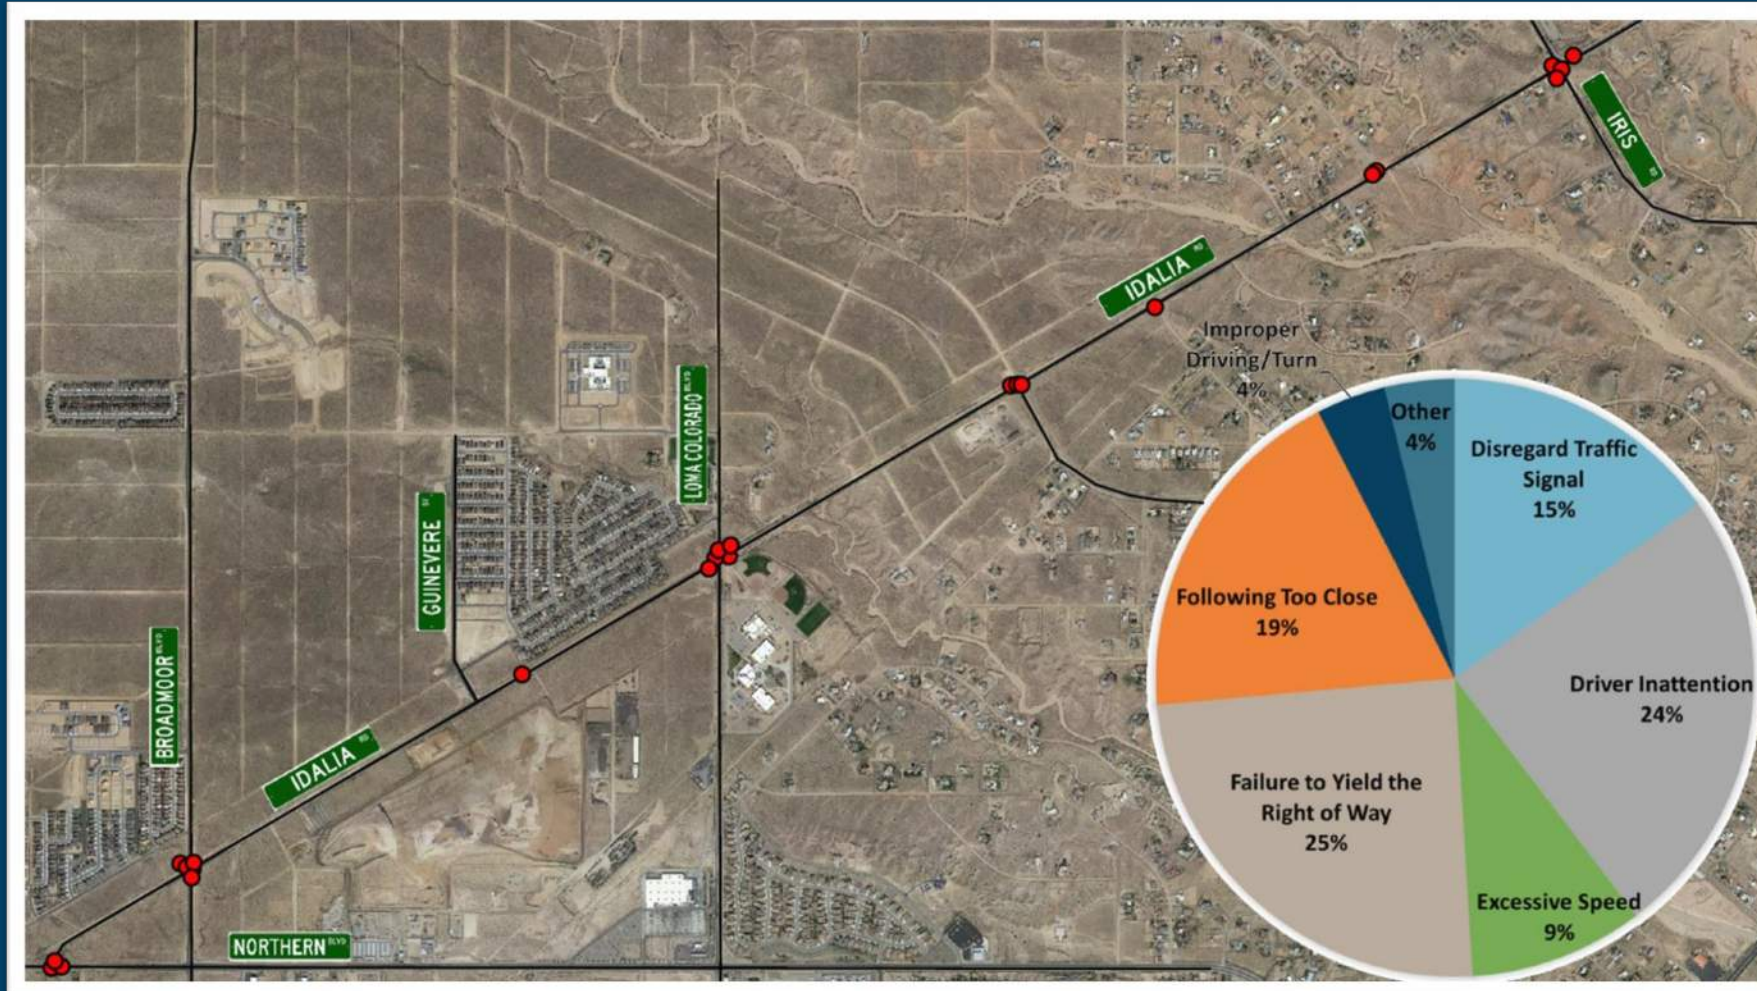
- **Crash History and Evaluation**
 - 53 crashes reported between 2015-2019
 - 68% of crashes involved property damage only
 - 32% of crashes involved injuries
 - 70% occurred during daylight hours
 - No fatalities reported or crashes involving pedestrians
